# **Case Study**

## **Corrosion Experiences using Hot Dip Galvanized Steel on South African Mines**

**R.E. Wilmot (Executive Director)  
Hot Dip Galvanizers Association  
Southern Africa**

**Intergalva 2012  
June 2012**

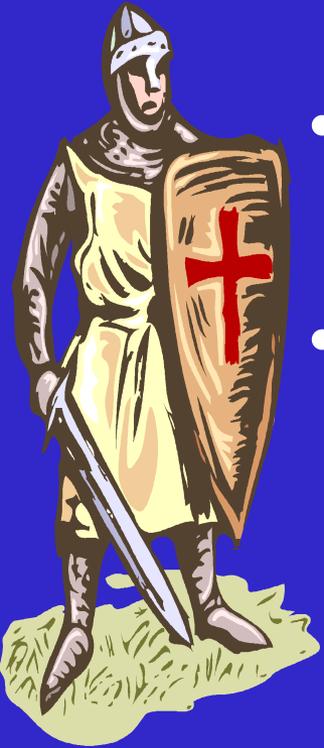
**Zn electro -ve to Carbon steel**

- **Reduced rate of attack** (Slowly corroding barrier referred to as **Sacrificial Protection**)
- **Greater coating thickness of HDG versus electro-plating.** (HDG 80µm – Zn Electro-plating <10µm) **Thicker coatings Longer Service Life.**

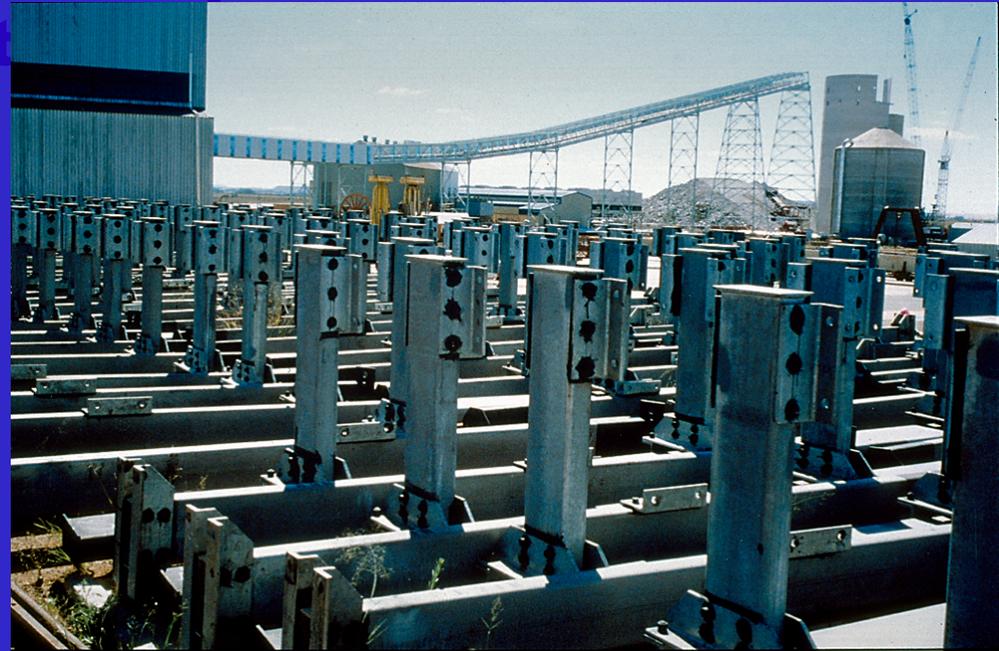
Note that on the Buntions additional “sealer” coatings have been applied to over the fasteners

Shaft Guides Measured  $> 250\mu\text{m}$

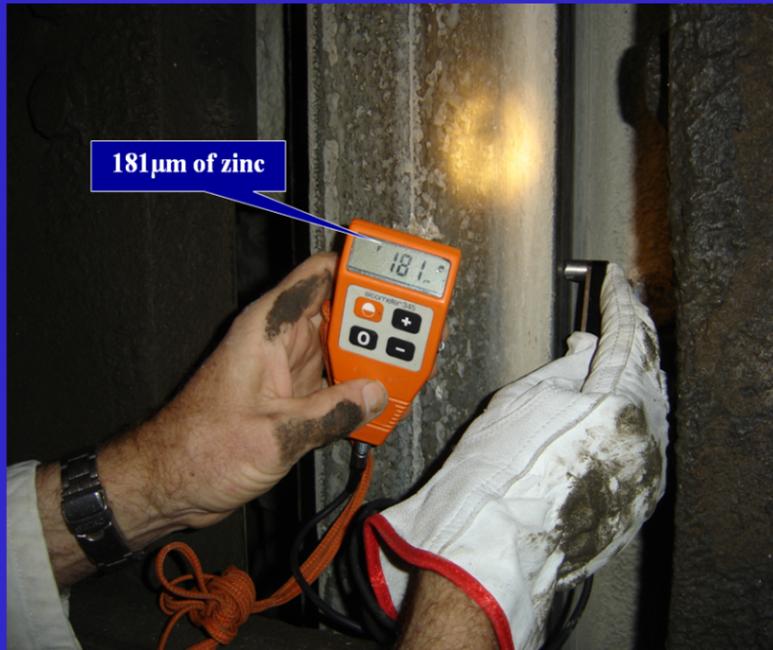
January 2003

Shaft Guide

Shaft Guides; Zinc was intact and being consolidated by the rolling action of the cage

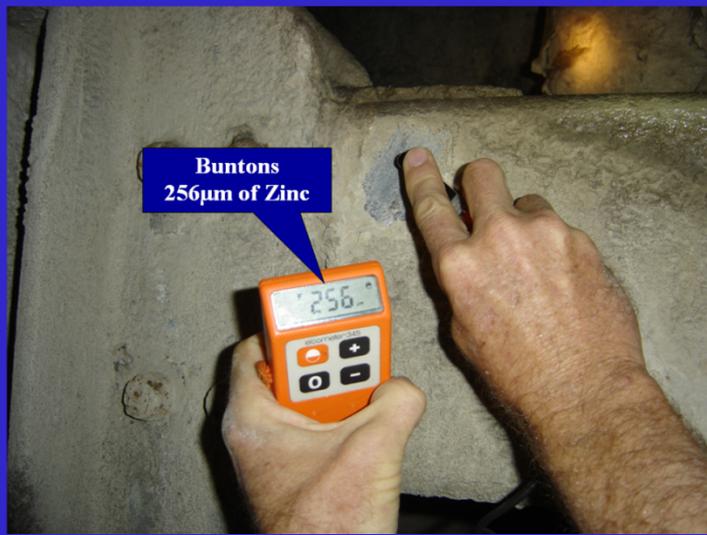
September 2006

Measurement on the wearing surface of the guide, indicates 181µm of hot dip galvanized coating

Examination of a buntion, 256µm of zinc coating was measured. It is important to note the areas where these measurements were taken are “dry”

Side of Bunton 234 $\mu$ m

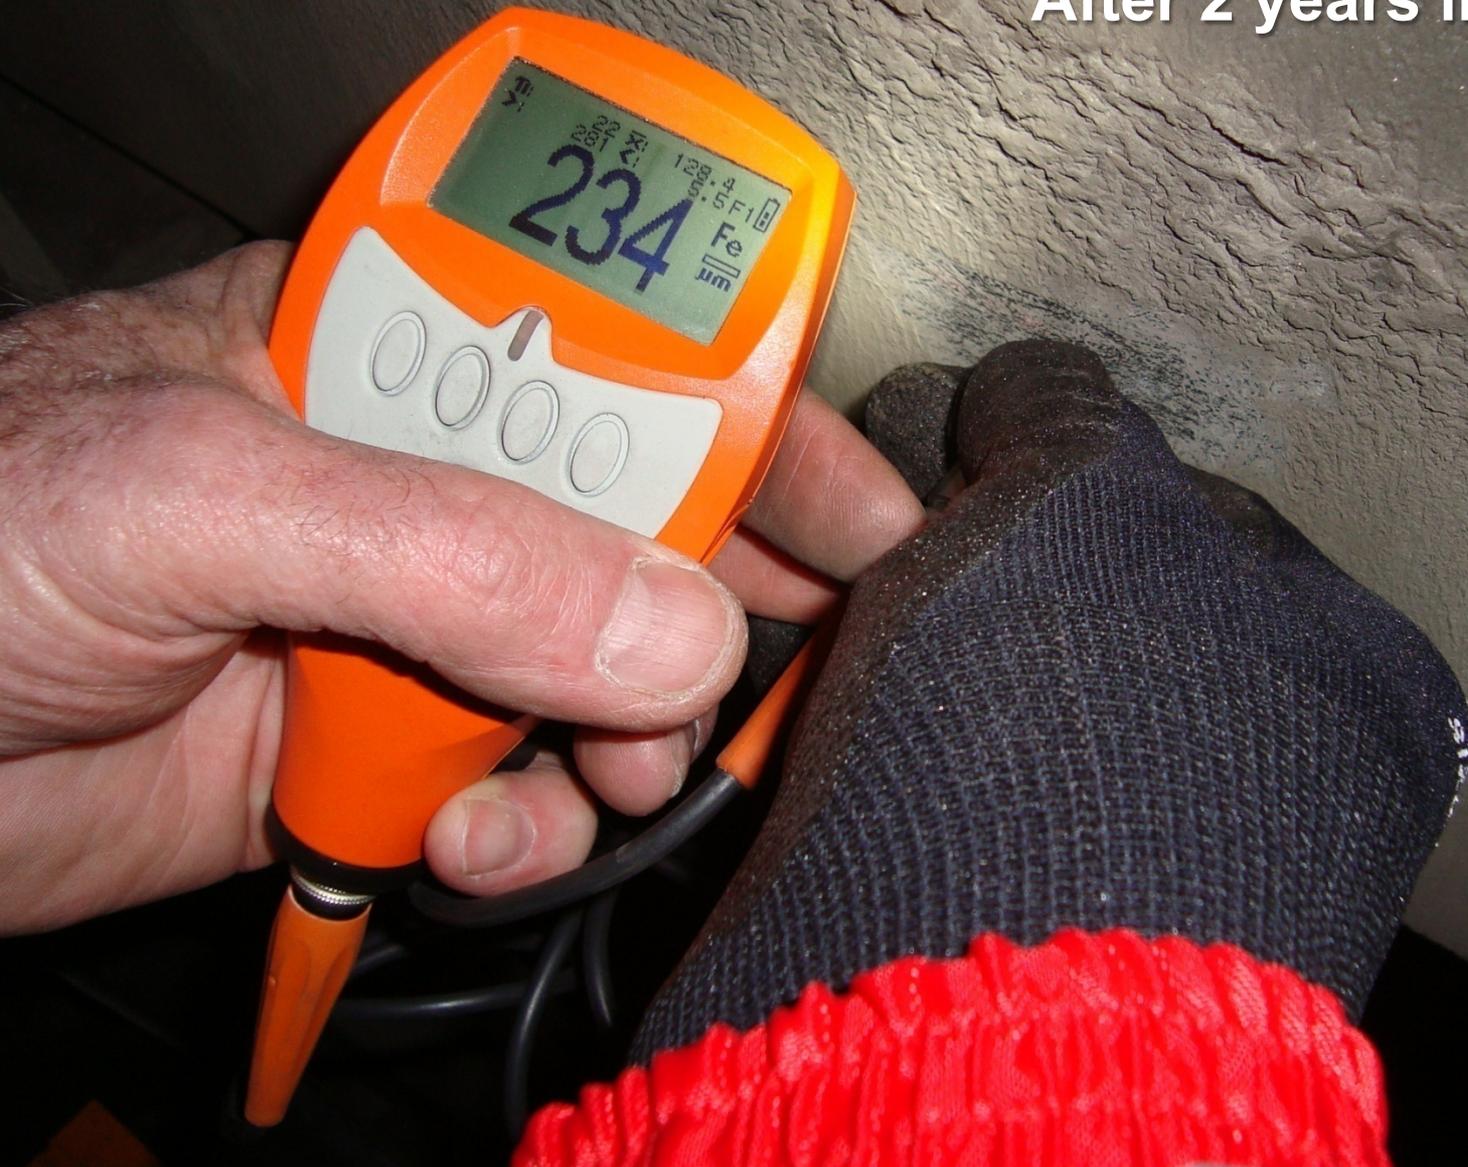
After 2 years in service

Tops of other buntions, in wet areas and near the side walls, have **Zero  $\mu\text{m}$  of zinc**

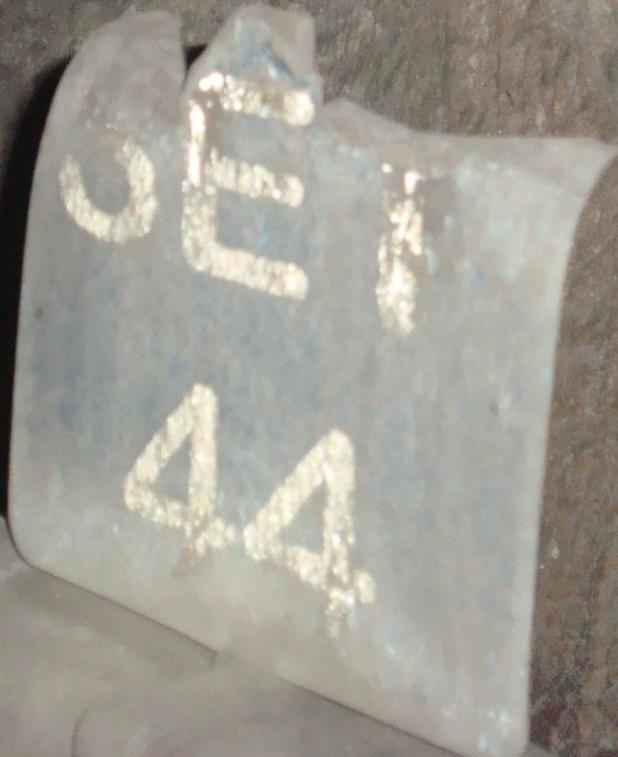
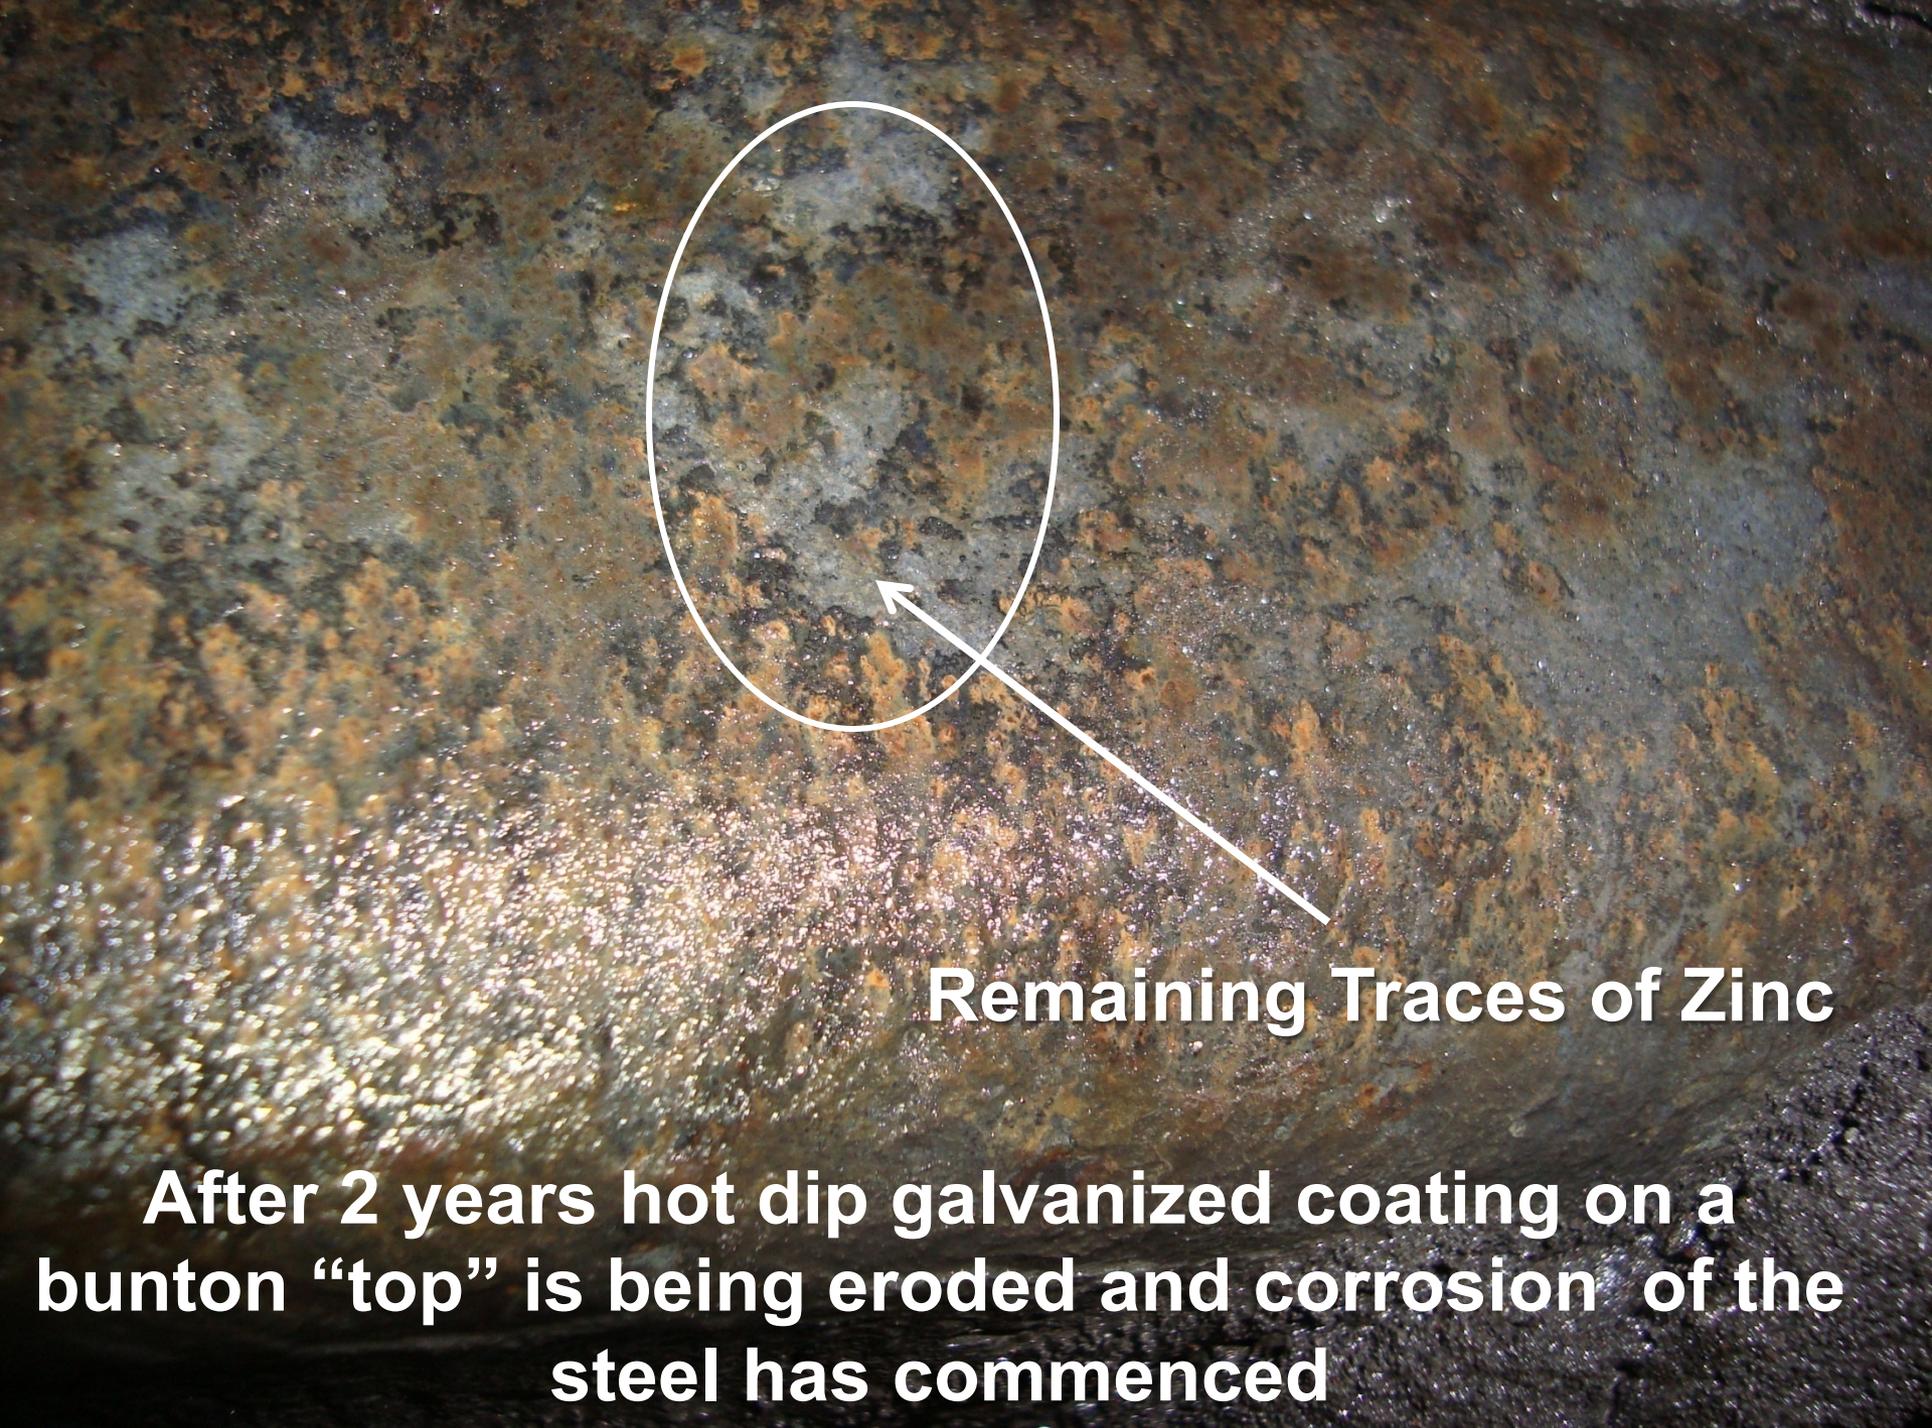
**Some of the Damage  
Caused by Falling  
Debris**

**Remaining Traces of Zinc**

**After 2 years hot dip galvanized coating on a bunt on "top" is being eroded and corrosion of the steel has commenced**

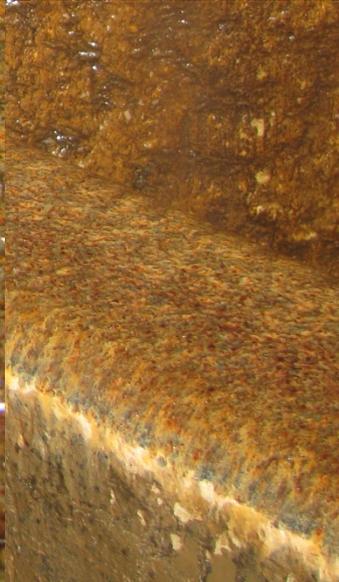
# Durability Concerns After approximately 12 years Service

**ion corrosion**  
the top of the  
n continuous  
air flow driven  
water droplets,  
nd debris

**1<sup>st</sup> line of defence, being the zinc carbonate layer, has been eroded away exposing the steel to erosion corrosion**

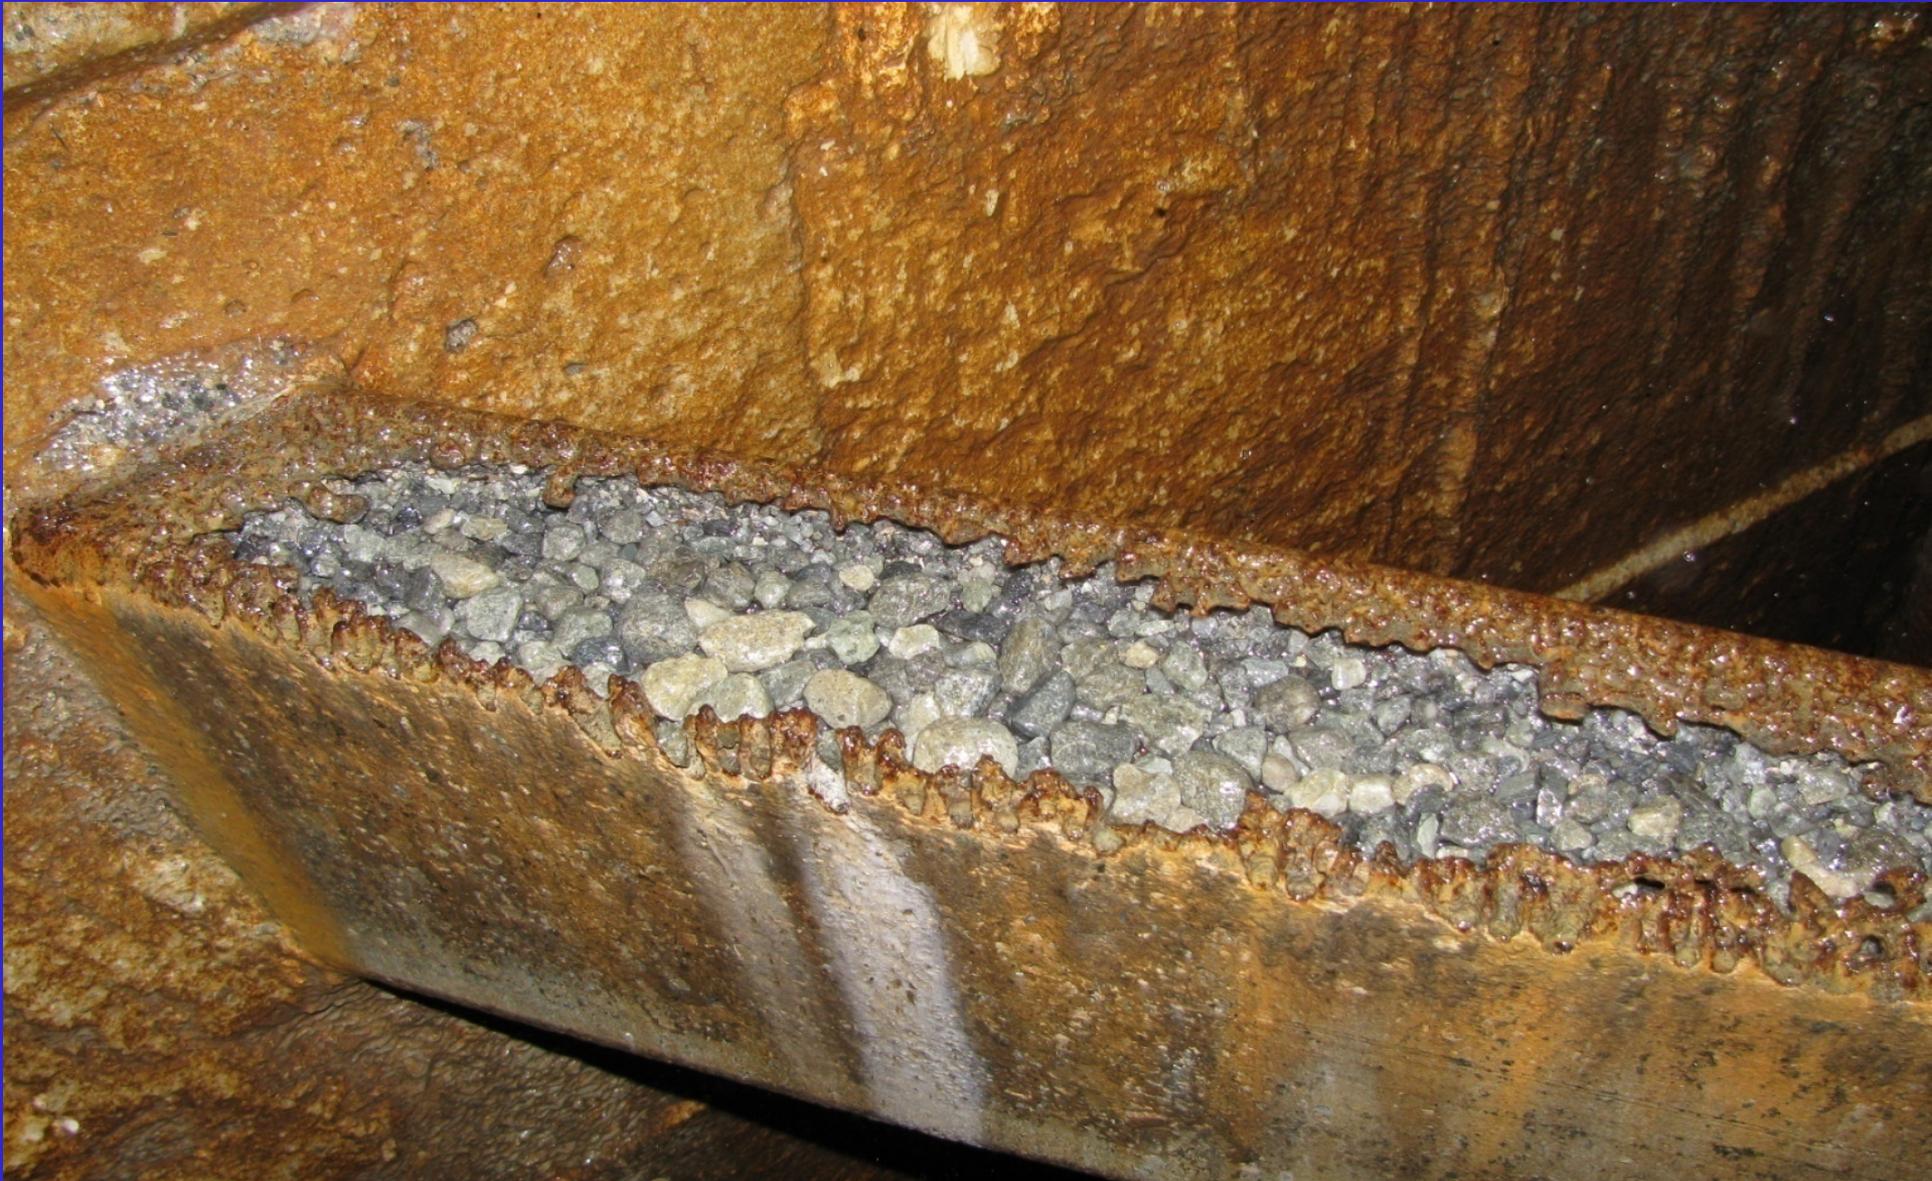
# More serious Erosion Corrosion of the buntan being destroyed (Always near the side wall)

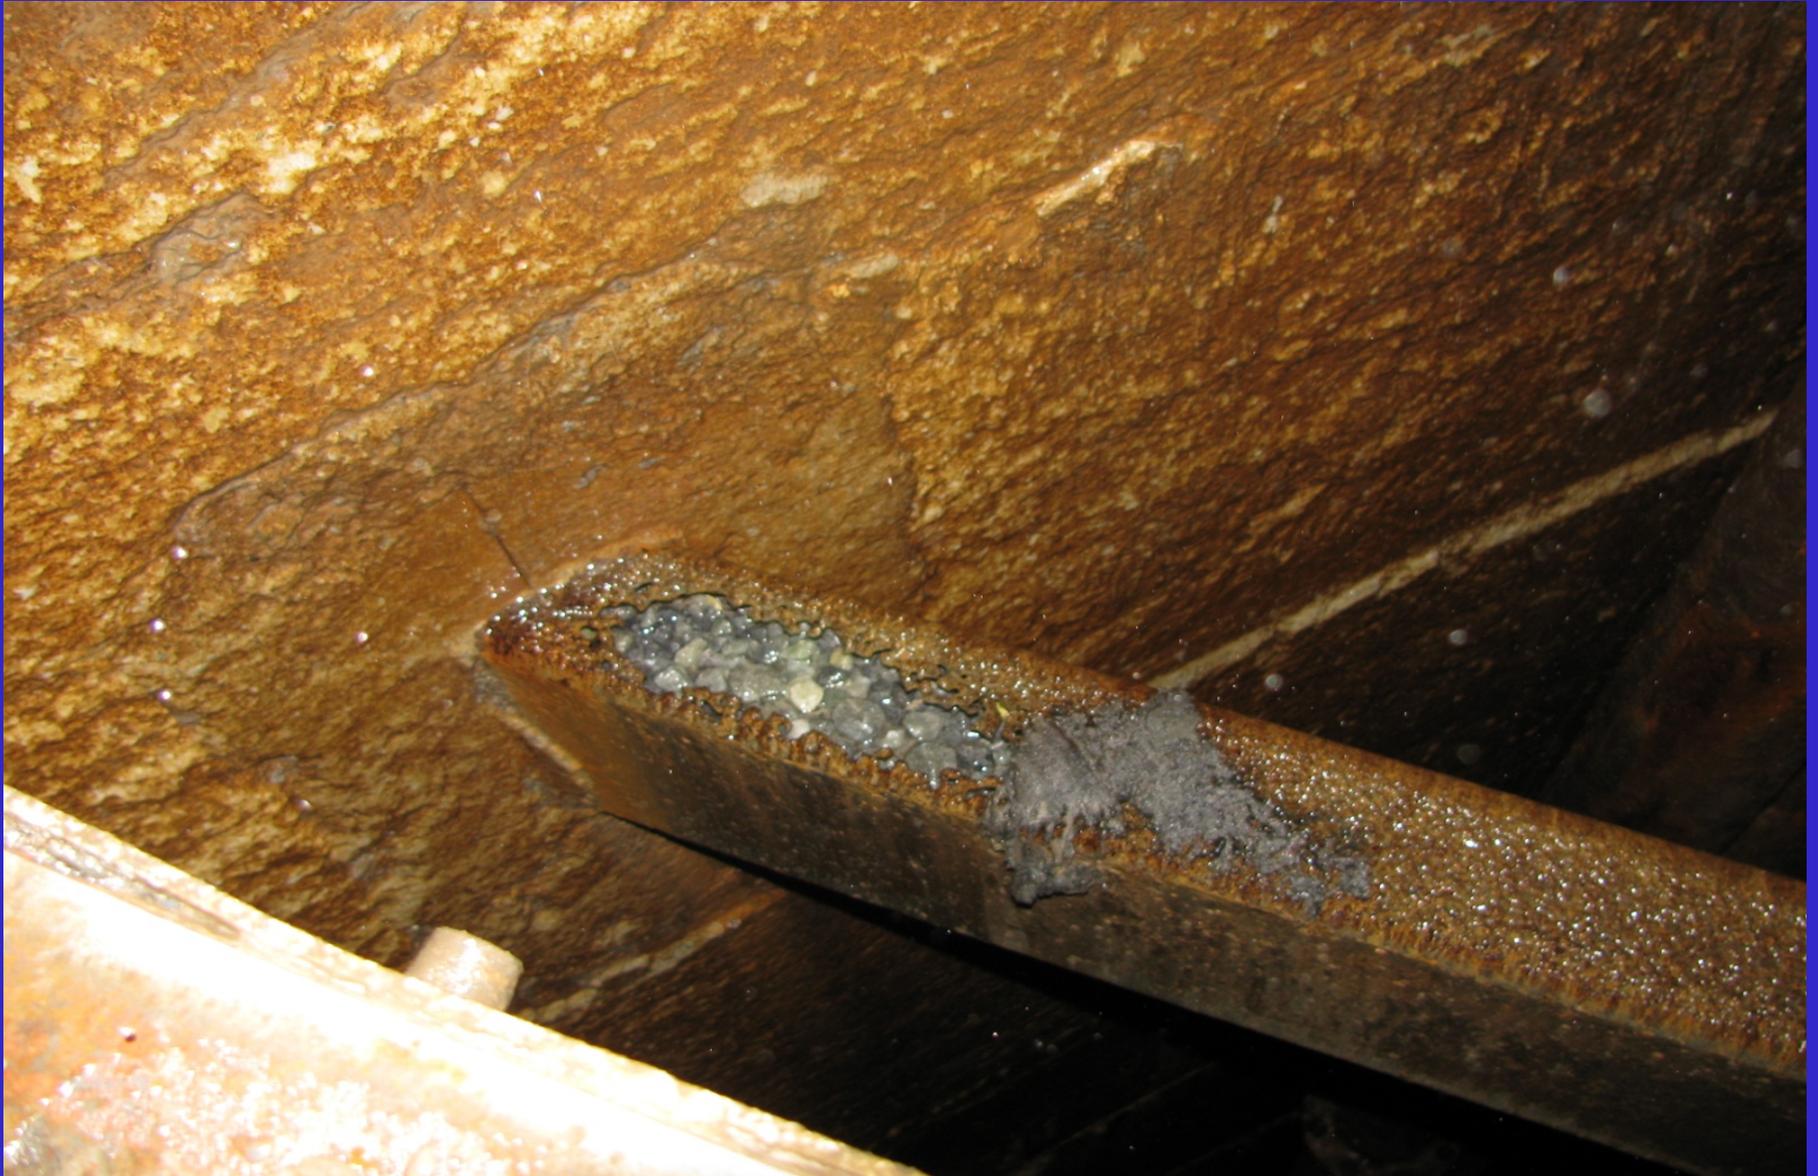
**Damage to bunton tops relate to water “raining” down the shaft, supplemented by dust and debris impacting onto the top of shaft steelwork, usually close to the side wall**

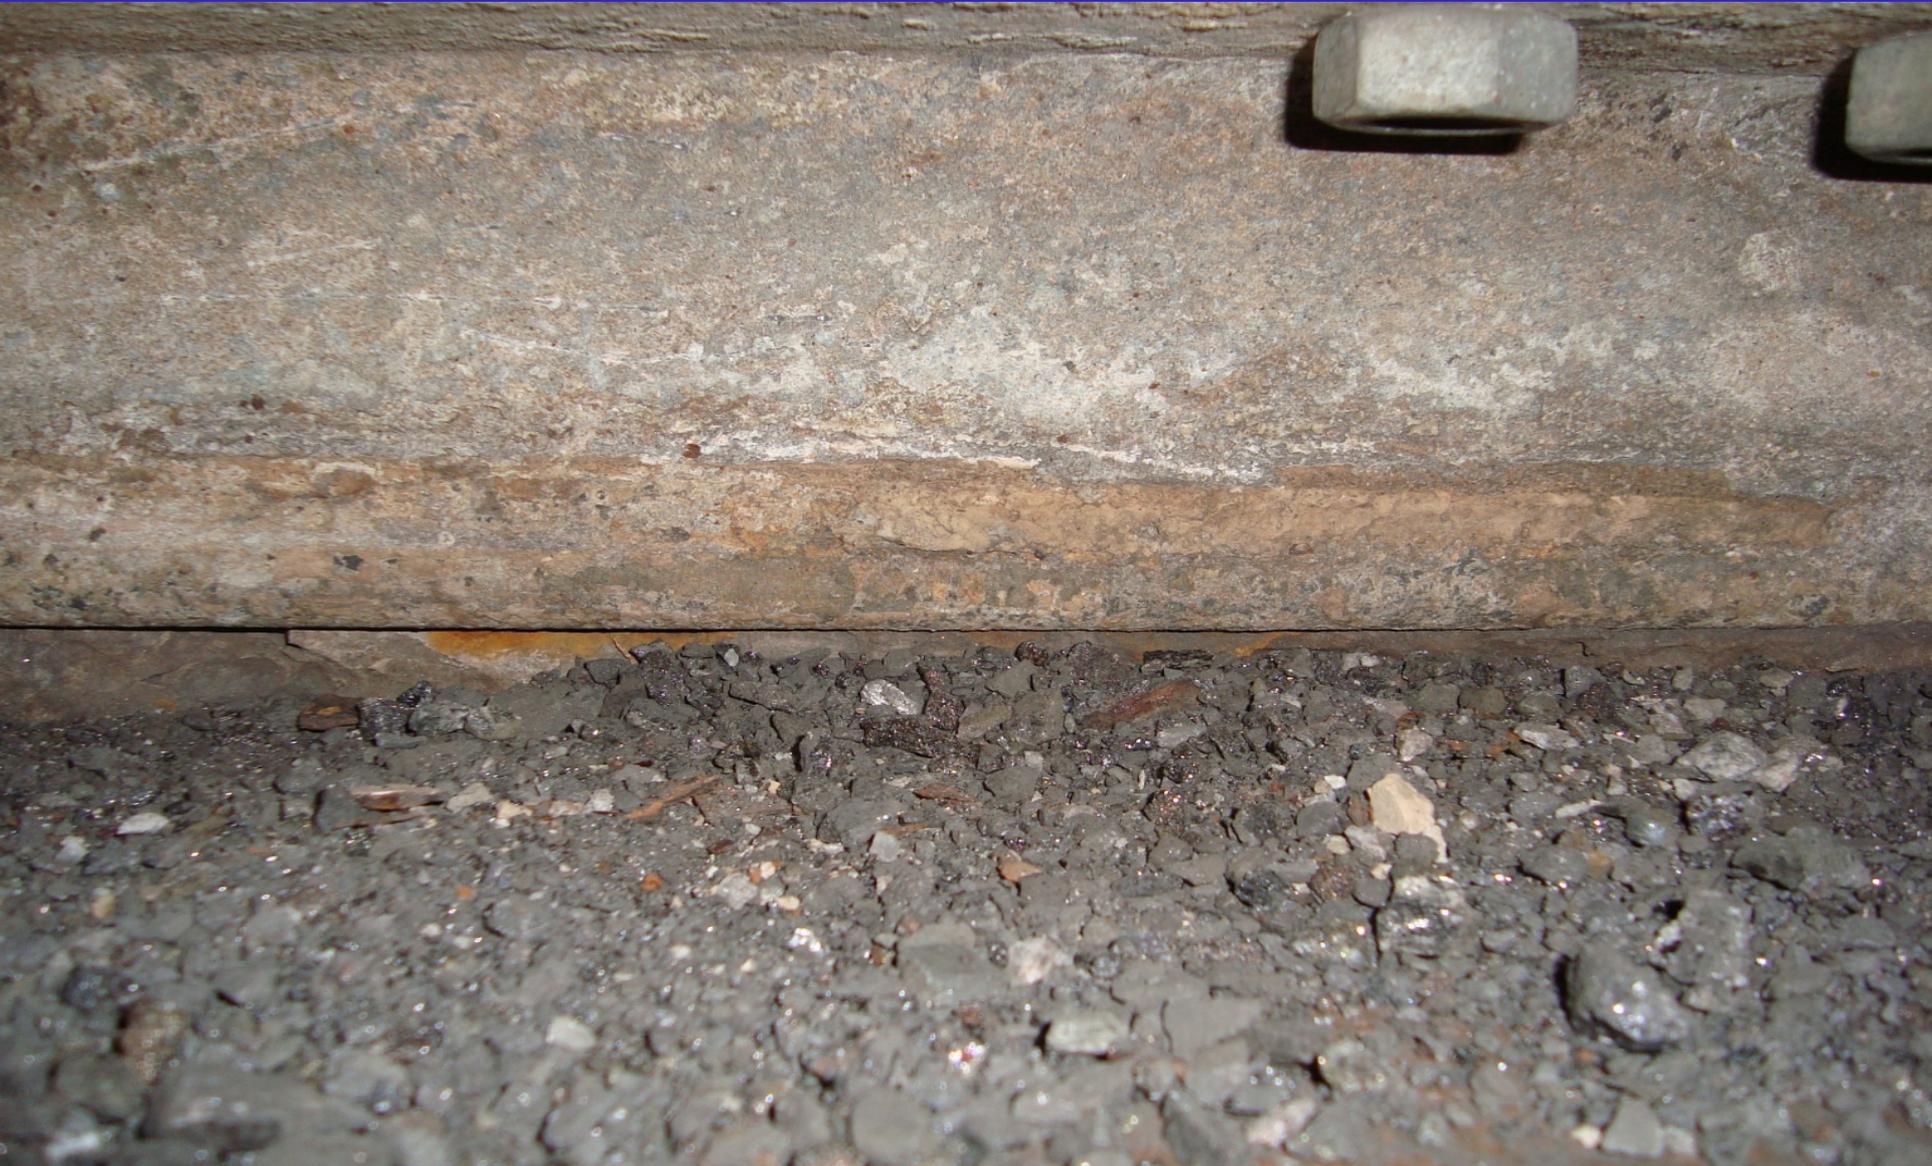
**Abrasive materials from the mining process added into air stream is extremely abrasive resulting in erosion corrosion attack of bunton tops.**

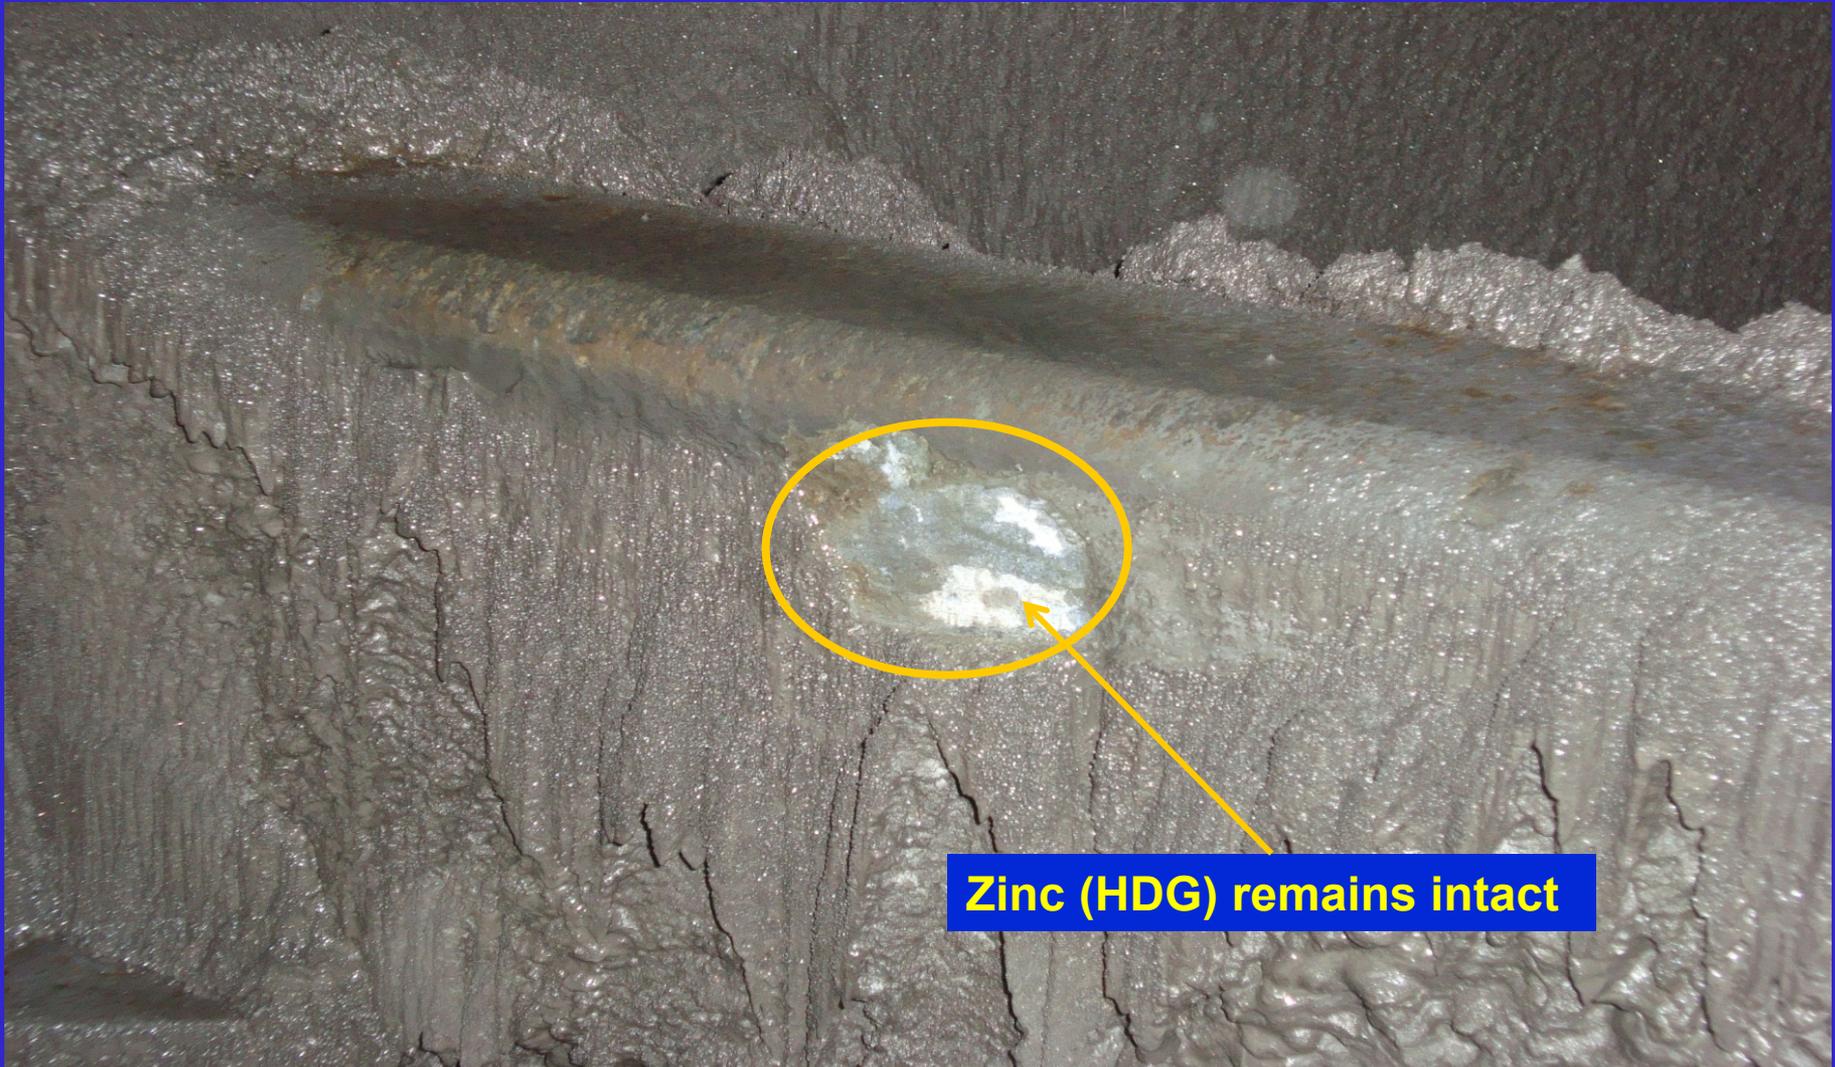
Corrosion control systems being eroded away, followed by **erosion corrosion** of steel until perforation

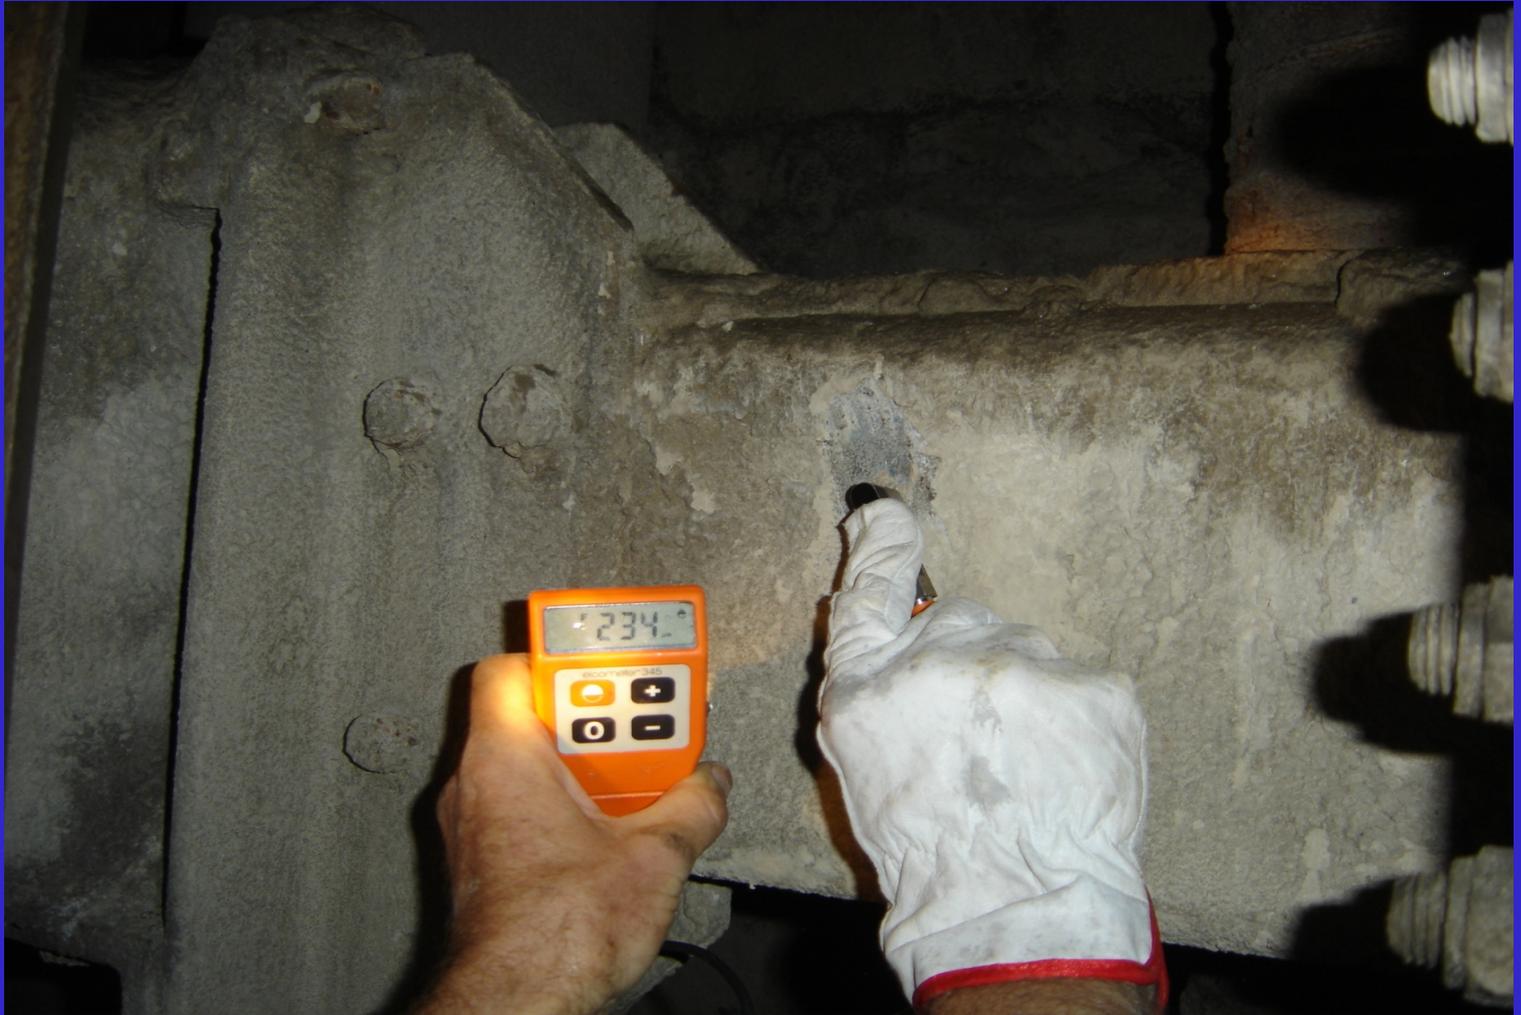
**From Mine 1**

**Zinc (HDG) remains intact**

2 years in service

**Sides and undersides of buntions retain near original hot dip galvanized protective coatings**
