# Practical Use of Advanced Image Processing System to Diagnose Residual Service Life of Galvanized Coatings

- D.E., Denro Corporation, Japan.

1. Aim of Diagnosing Residual Service Life by Advanced Image Processing
2. Deterioration Diagnosis by Advanced Image Processing
3. Definition of Evaluating Deterioration
4. Method of Calculating Residual Coating Thickness
5. Accuracy of Diagnosis by Advanced Image Processing
6. Example of Diagnosing Residual Service Life of Galvanized Coatings
7. Conclusion

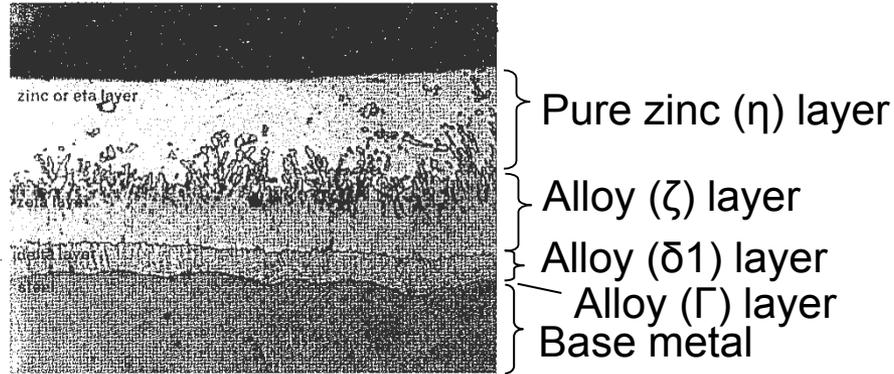
Table-2 Definition of deterioration levels of hot dip galvanized surfaces

- The advanced image processing system analyses color of galvanized surfaces by computer to evaluate the deterioration levels through using the property that galvanized surface color changes as the alloy layers expose.
- Levels of deterioration of galvanized surfaces are standardized according to Table-2 depending on exposure of the alloy layers.

Deterioration levels	Deterioration of hot dip galvanized surfaces	Evaluation by advanced image processing
I	Normal condition keeping $\eta$ layer (pure zinc layer) with color of silver or gray	Blue
II	Slightly deteriorated condition where $\eta$ layer is corroded and $\zeta$ layer is locally exposed with white rust, stains and color of brown or dark brown partially	Light blue
III	Rather deteriorated condition where $\eta$ layer is corroded and $\zeta$ layer is wholly exposed with color of brown or dark brown	Yellow
IV	Very deteriorated condition where $\zeta$ layer is corroded, and $\zeta / \delta 1$ mixed or $\delta 1$ mixed layer is exposed with color of auburn or flecked auburn	Red
V	Extremely deteriorated condition where base metal is exposed with brown color and bumpy surfaces	Brown

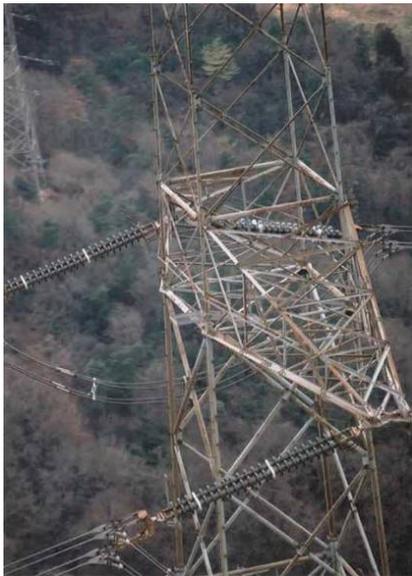
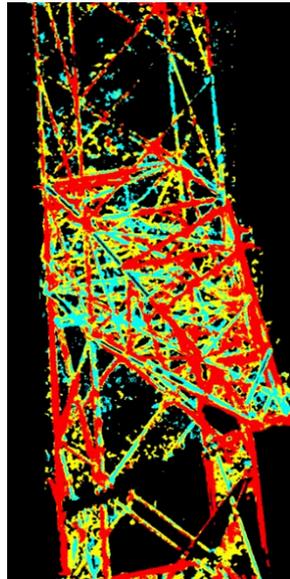
Deterioration levels

Diagnosed image

Result treated by advanced image processing

Results of diagnosis	
(1) Evaluation of deterioration levels	Evaluated as deterioration level IV, which is in the worst case.
(2) Occupying ratio of each deterioration level in the image diagnosis	I: -%, II: 20%, III: 38%, IV: 42%, V: -%
(3) Calculation of galvanized coating thickness	Calculated galvanized coating thickness when applying 550g/m <sup>2</sup> (76.4μm) as our in-house production standard I: -, II: 48μm, III: 33μm, IV: 16μm, V: -
(4) Diagnosis of residual service life of galvanized coatings	In consideration of the elapsed time (20 years) and deterioration level (IV) of diagnosed materials, their residual service life would be about 2 years.
(5) Countermeasure	It is recommended to immediately check out their deterioration in detail.

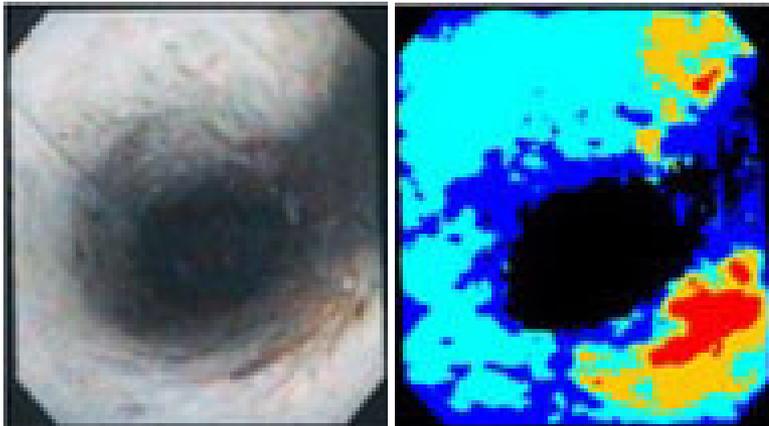
Deterioration levels

Diagnosed image

Result treated by advanced image processing

Evaluated as deterioration level IV, which is in the worst case.

I: 26%, II: 46%, III: 16%, IV: 12%, V: -%

I: 66μm , II: 48μm , III: 33μm, IV: 16μm, V: -

In consideration of the elapsed time (36 years) and deterioration level (IV) of diagnosed materials, their residual service life would be about 3 years.

It is recommended to immediately check out their deterioration in detail.
